**Maintenance Manual
Repair Manual**

MAINTENANCE MANUAL

FOR THE GLIDER MODEL

ASK 23

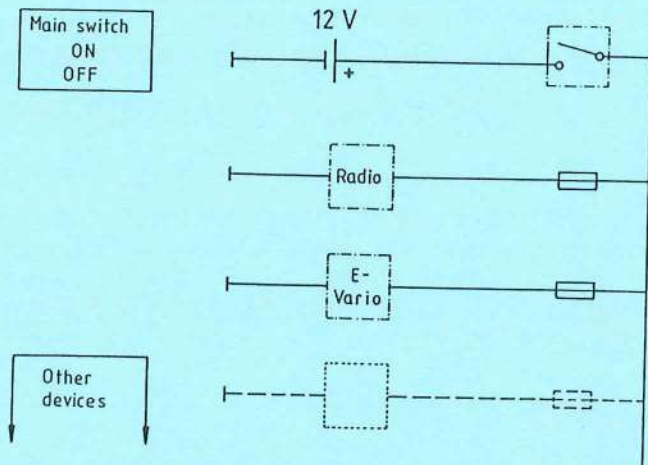
II.5. ELECTRICAL SYSTEM

The wiring diagram provides details of the electrical system.

Fuse each unit according to manufacturer's data !

One battery is used as power supply.

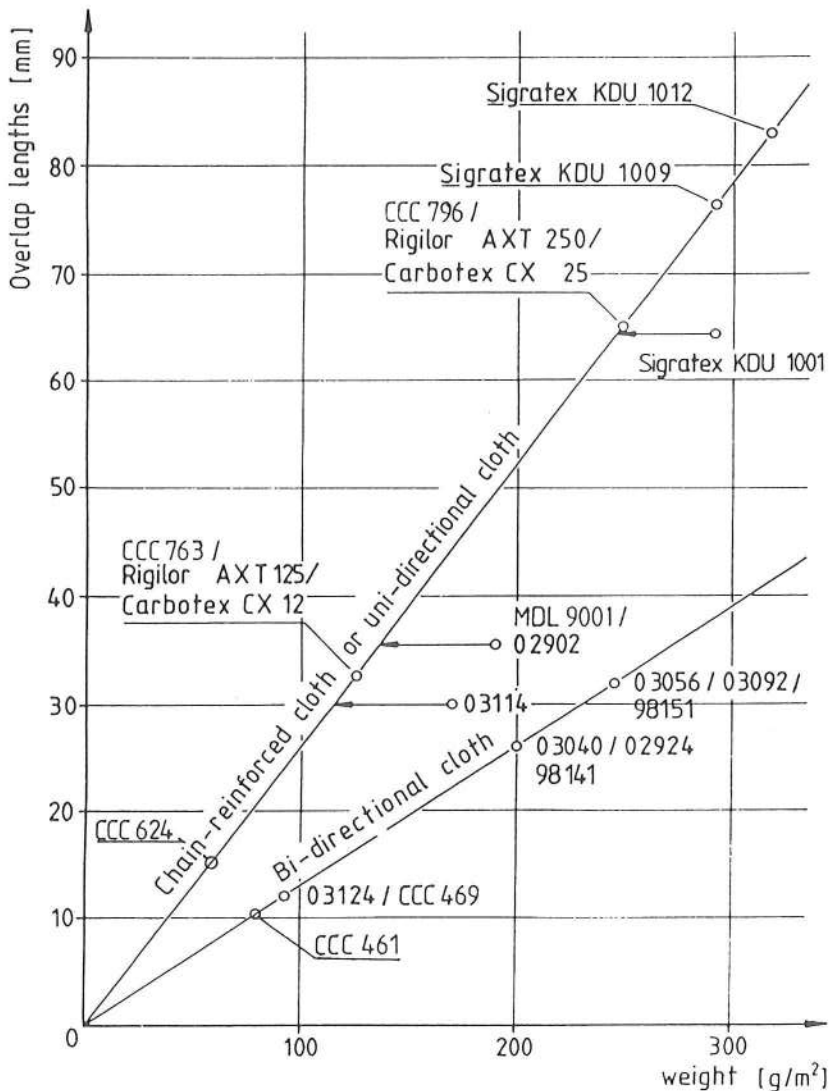
Diagram: overlap length for Carbon fiber

Scarf lengths are half as long as overlaps.
